SBI Test Report - EN 13823

Standard used: EN 13823:2010 + A1:2014
 Date of test: 09-09-2015
 Full test duration/performed: Yes
 Smoke correction performed: No
 Report identification: OMC127A/15

Product
 Product identification: Organic blocks
 Sample number: 1
 Thickness [mm]: 0
 Mass per Area [kg/m²]: 0

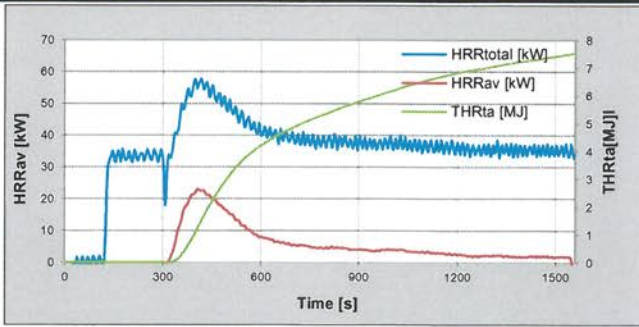
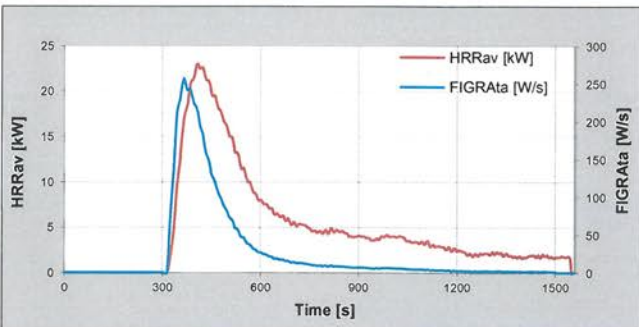
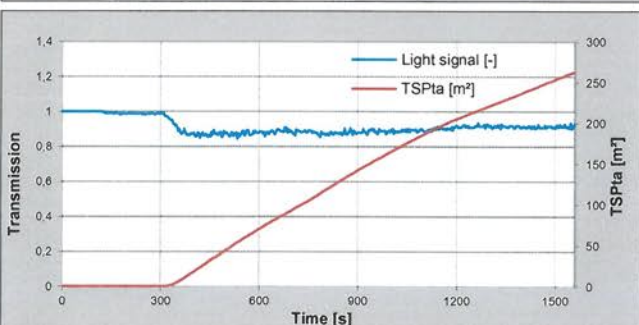
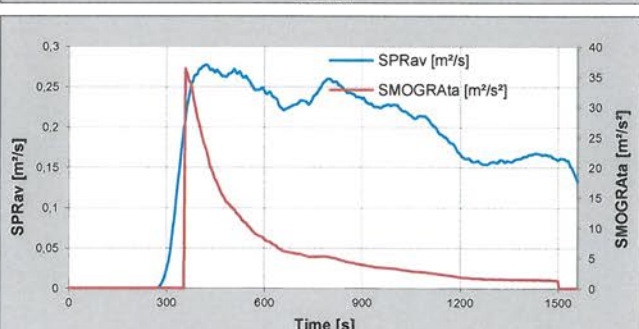
| FIGRA_0.2 [W/s] | 257,12 | | |
| FIGRA_0.4 [W/s] | 257,12 | | |
| FIGRA [W/s] | 257,12 | D | D |
| THR600s [MJ] | 5,78 | B | |

| SMOGRA [m²/s²] | 36,42 | | |
| TSP600s [m²] | 142,09 | | S2 |
